**BEFORE THE
FEDERAL COMMUNICATIONS COMMISSION
WASHINGTON, D.C. 20554**

Reply Declaration of Michael T. Harrelson, P.E.

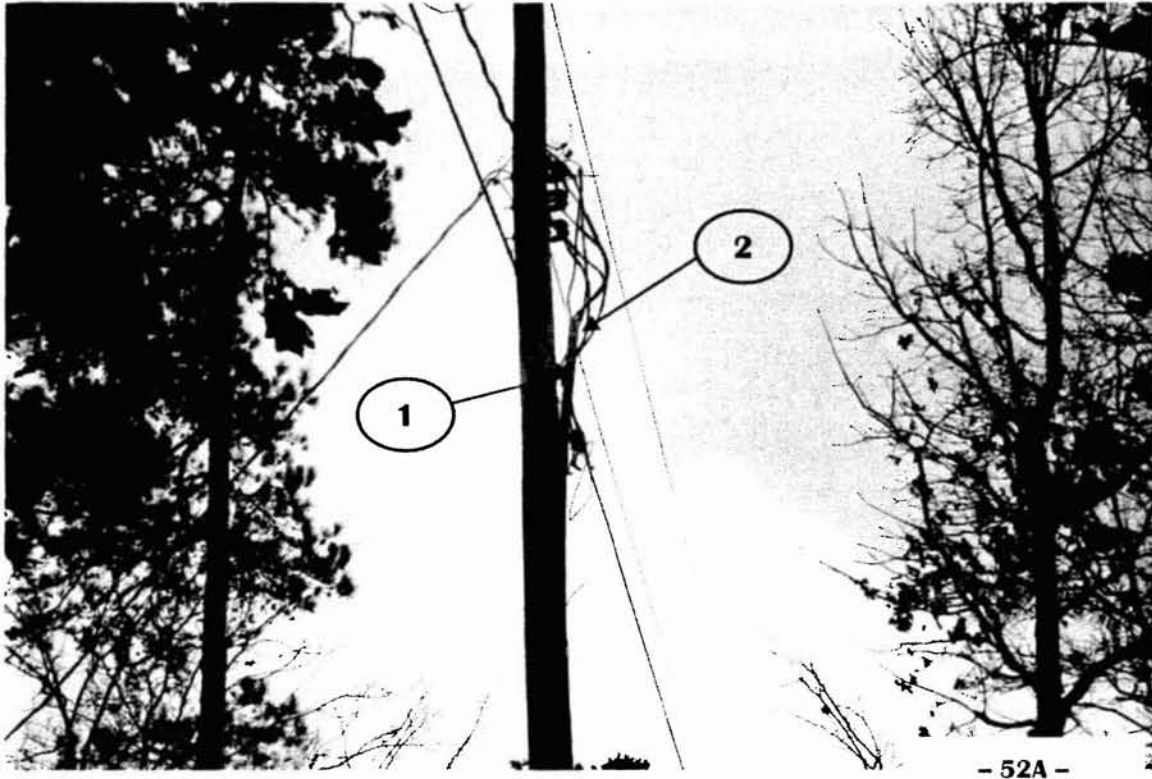
This photo depicts a typical EAI configuration in Arkansas. Not only has the power company installed the electric riser and conduit literally on top of the cable television facilities (Arrow #1), but the riser is too short (Arrow #2), creating multiple violations of the electric-to-communications clearance standards of the NESC. Note also the “fly-away” appearance of the riser conduit. These electric cables above the riser pipes, which pin cable television poles and preventing CATV workers from accessing facilities without touching power, should be corrected immediately by EAI. This photo was taken at the direction of Marc Billingsley of Comcast.

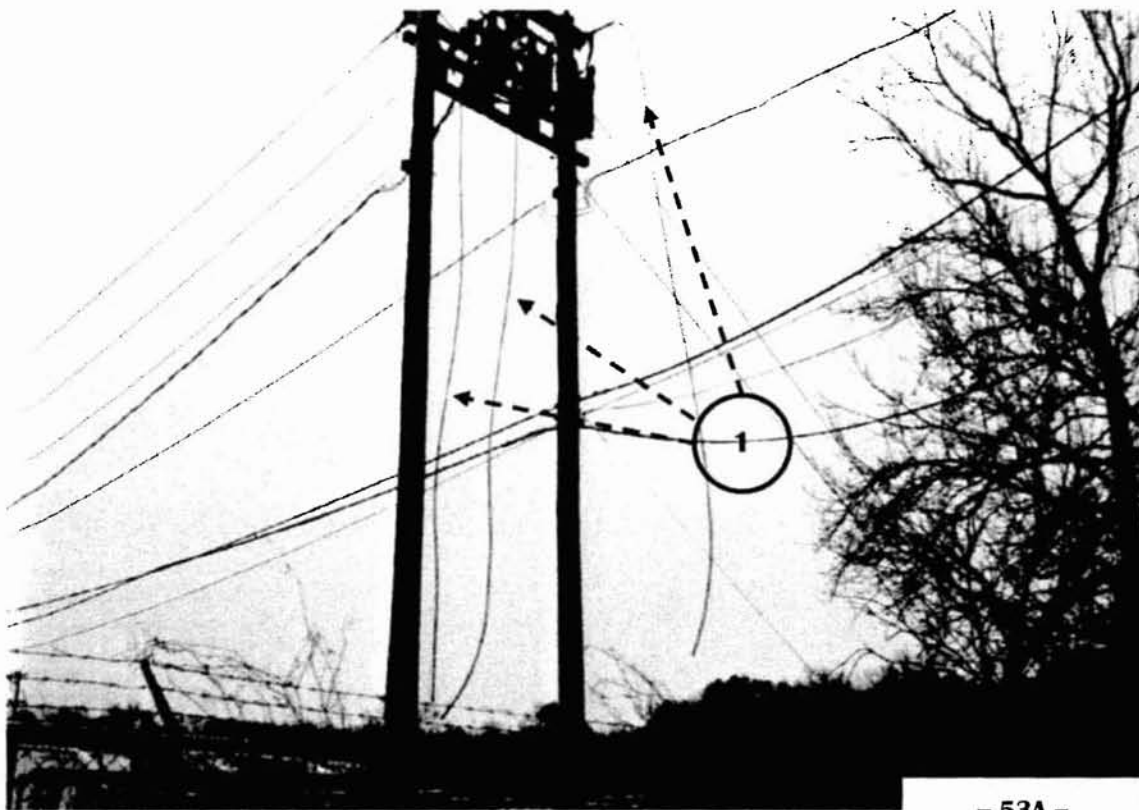
- 53A -

This photograph which was taken at the direction of Marc Billingsley of Comcast, shows dead primary lines hanging down (Arrow #1) from the top of high-voltage power distribution poles near an abandoned bicycle factory at 6301 Patterson Road in Little Rock. The power lines, even though apparently de-activated, create a dangerous situation because they touch the cable television support strand and they hang down low to the ground. The work rules of the NESC apply to electric workers and communications workers. They do not permit workers to treat such lines as dead unless they are disconnected from the source, tested for absence of voltage and grounded. Further, NESC rule 214.B.3. states that lines permanently abandoned shall be removed or maintained in a safe condition. These abandoned lines create serious hazards for workers and the public.

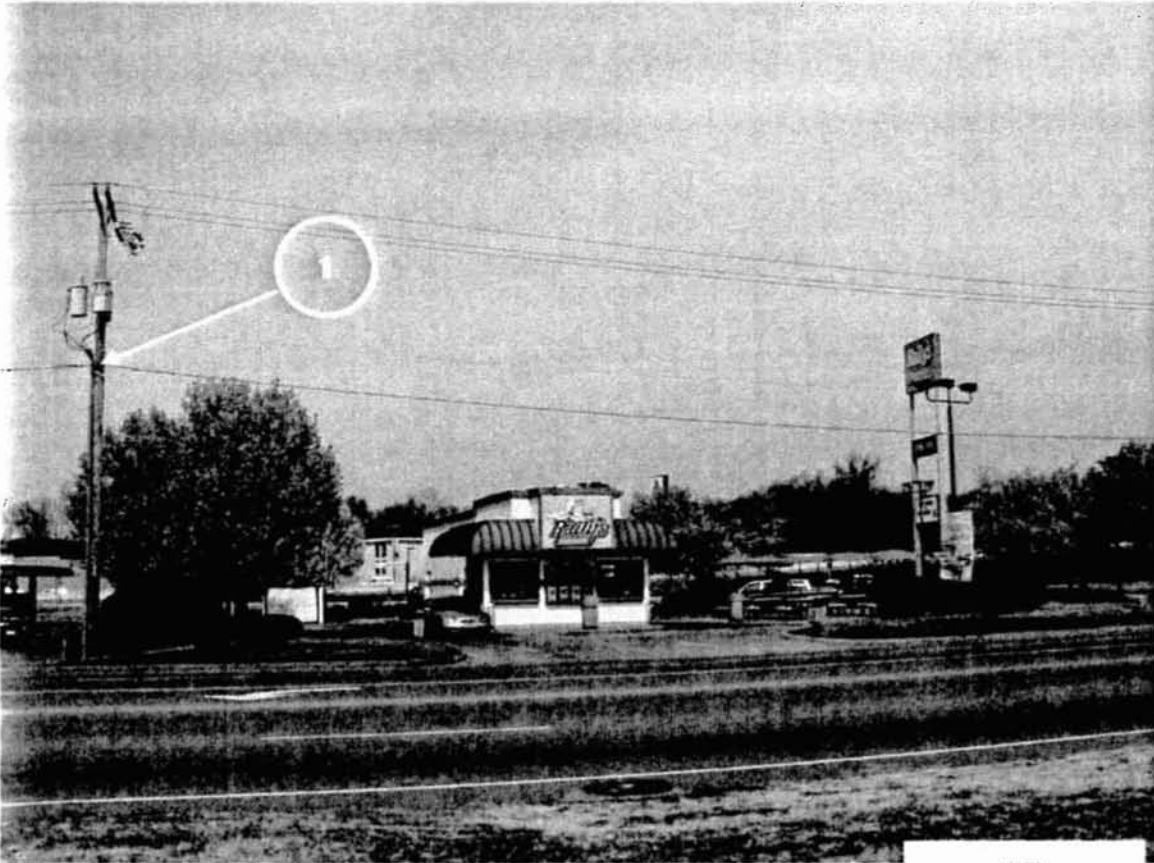
- 54A -

This photo, which I took, shows a pole at the left where there is a new underground electric service riser, with the riser pipe stopped about 4 inches above the cable television facilities (Arrow #3). EAI could have easily installed this service riser to a place above the neutral wire, which would meet the NESC 40" requirement. I was present during a make ready field meeting held on March 24, 2005 to accommodate a project for another communications company in the area needing access to EAI poles. At that meeting EAI and USS told Comcast that they would not extend this riser and would not accept responsibility for fixing the violation that it created. Location: Jacksonville, AR, N. First ST.

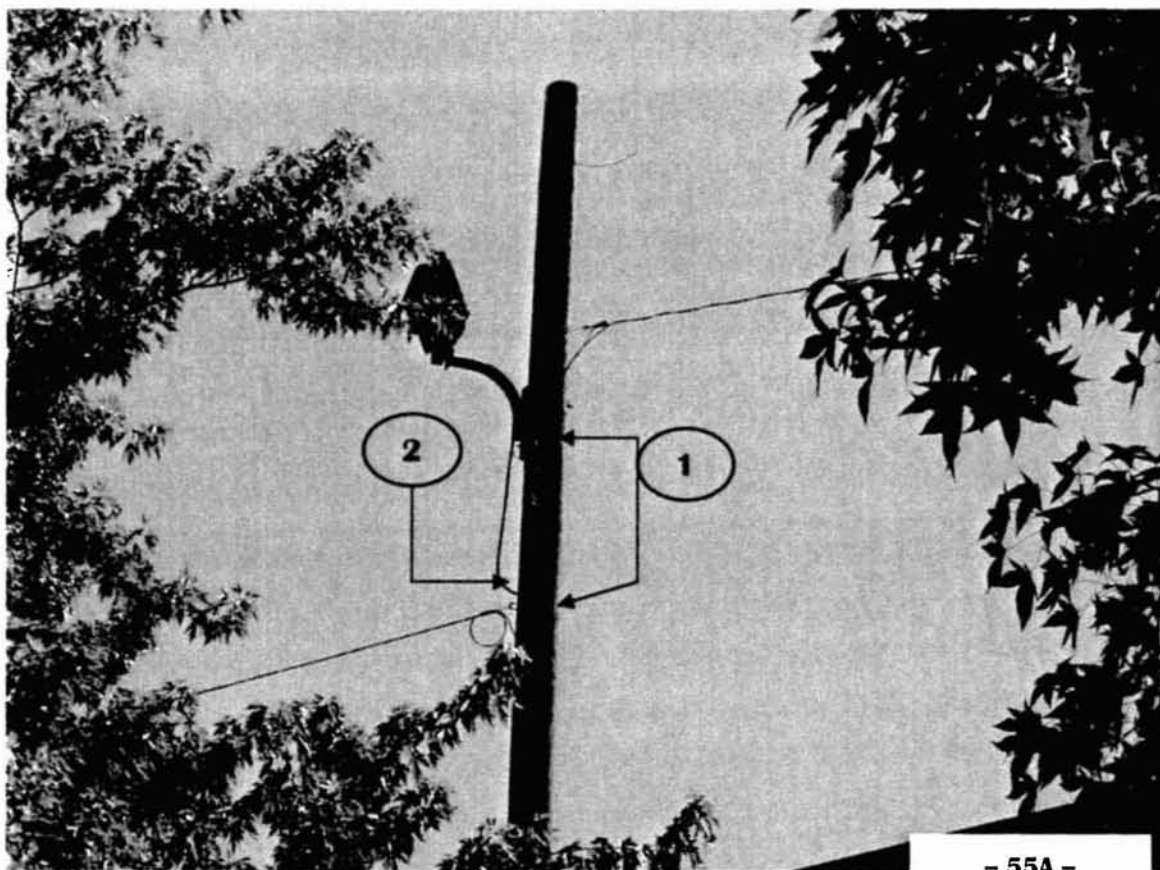
This new street light illuminates the parking lot at the Comcast building in Little Rock. There is ample separation between the light bracket and the communications drop (Arrow #1) but EAI has built this new light with excessively long power leads (Arrow #2), hanging down closer than 12 inches above communications. Location: Little Rock, Enmar Dr.

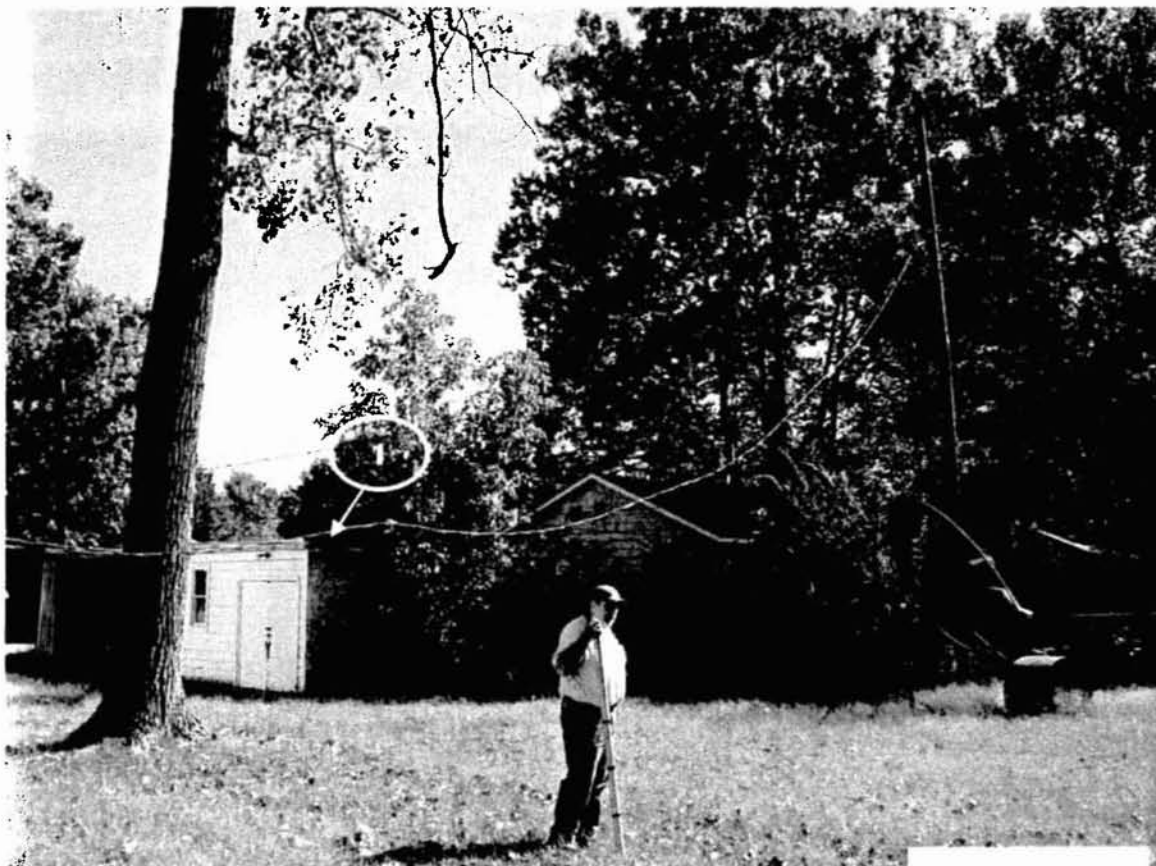
- 56A -

The power lines in this photo, which I took, are along back lot lines between houses. This power drop (triplex cable, 240/120 volts (Arrow #1)) has pulled loose from the house and is being held up by a Comcast drop wire to the same house. Good communications, cooperation and fairness help keep these types of problems from getting out of control. Location: Jacksonville, AR.

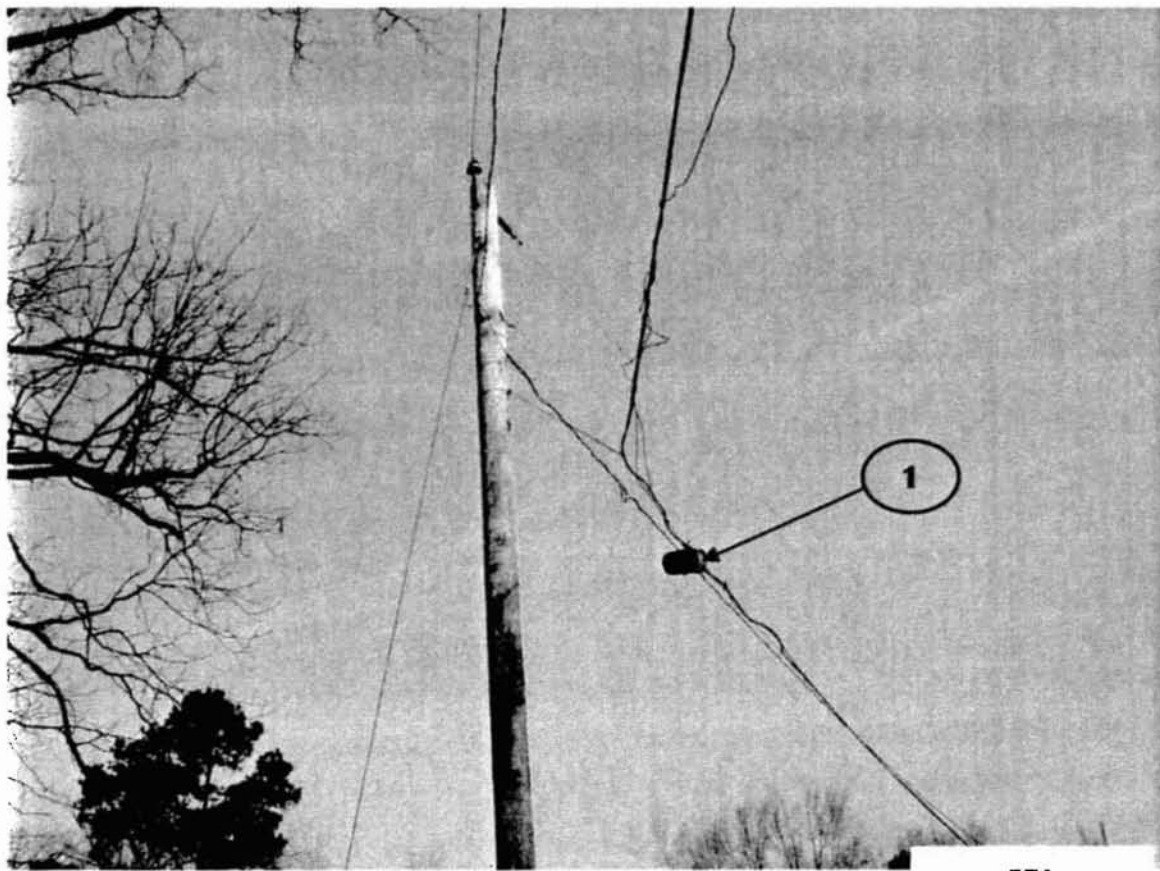
- 57A -

This photo, which I took, shows another EAI pole that apparently was broken by a vehicle. EAI tied Comcast's cable, plus a big chunk of the pole that it had sawed off from the old pole with a piece of scrap wire (Arrow #1). Comcast discovered this during a make-ready ride-out to assist another party in gaining access to Entergy poles in March 2005. This is a good example, and there are countless other ones, where EAI simply did not inform cable that it had performed work on the cable tv facilities. This continues to be a big problem. Location: Jacksonville Hwy 67/267.

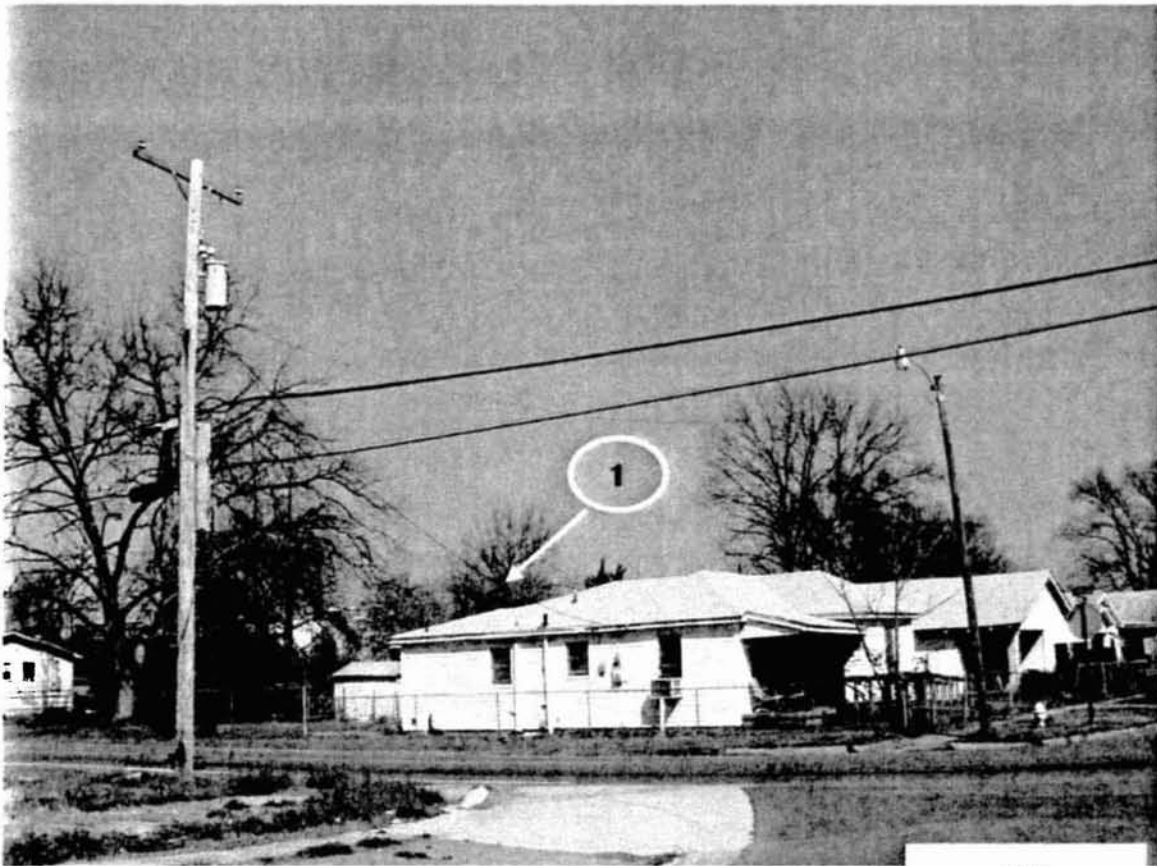
- 58A -

This photo, which I took, shows a very low electric service that is only 12 feet above the street (Arrow #1). NESC Rule 232 Table 232-1 requires it to be 16 feet. Unless it is raised, eventually a tall vehicle will pull this hot electric wire down. Location: Little Rock E. 11th St and J.L. Hawkins St.

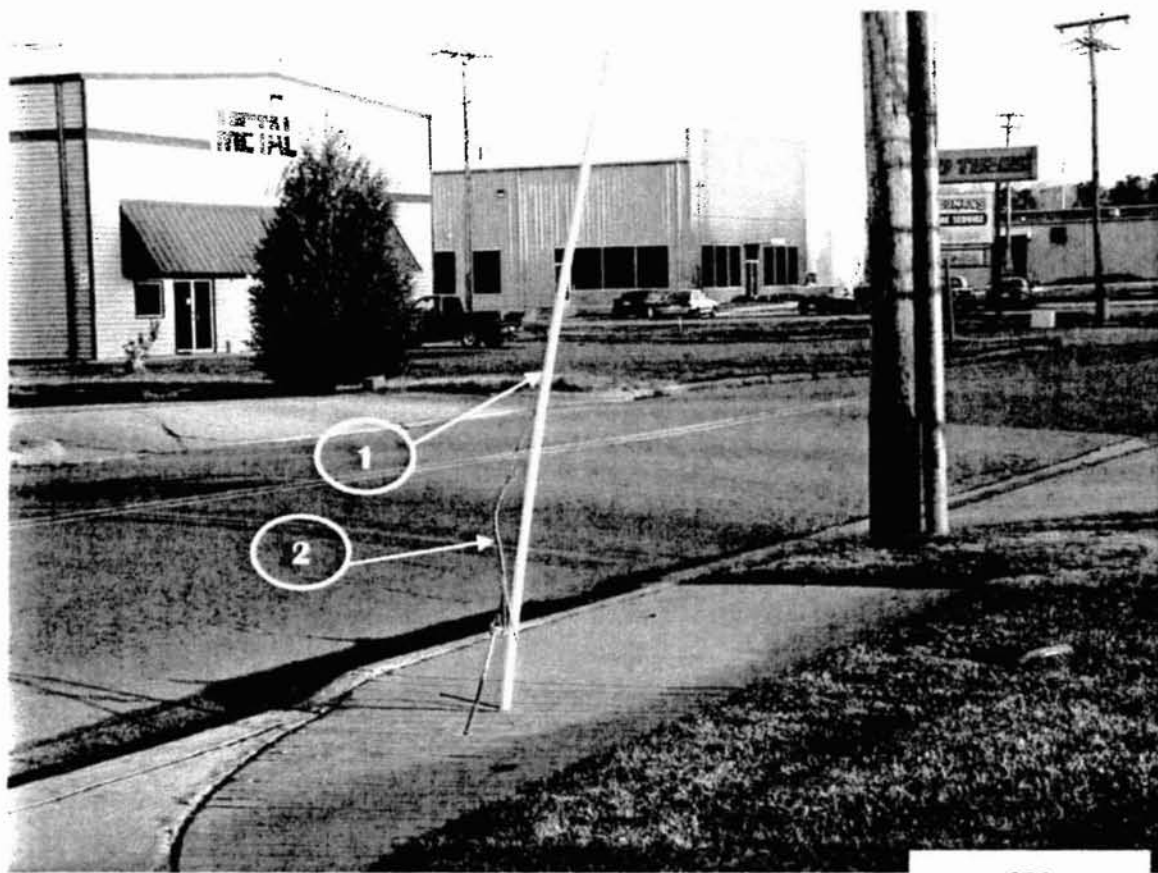
- 60A -

This photo, which I took, shows where EAI placed a new bright yellow guy marker (Arrow #1) on its steel down guy, but ignored the much more serious issue of the slack down guy that was providing no stability or support to the pole. In fact the guy was so slack the guy marker could not stay on properly (Arrow #2). The next pole in the span also contained a slack guy, which caused the two poles to bend in toward one another creating unacceptable slack in the span. Location: Little Rock, Enmar Dr.
